# FARAD<sup>®</sup> made in Italy

Instruction manual

## KIT PR25 - 6

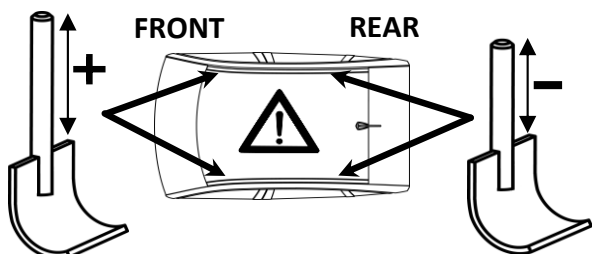
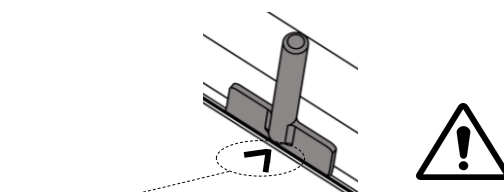
**FAILURE OBSERVE THIS NOTE CAUSES GLASS BREAKAGE**

**SUNROOF SIGN**

**Make sure the clip is well engaged inside the metal receiver under the glass. Clip well fitted must not be able to move back and forth. Repeat this check controll at all 4 fix points**

**FAILURE OBSERVE THIS NOTE CAUSES GLASS BREAKAGE**

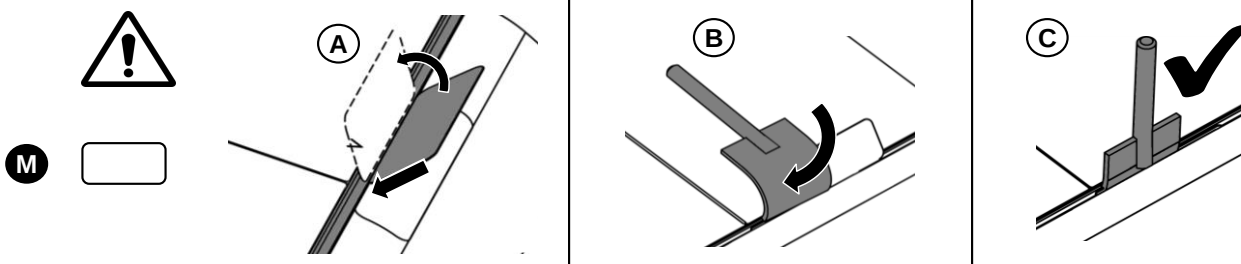
INSIDE RECIVER  
Correct fitting

OUTSIDE RECIVER  
Wrong fitting
